Tererro Mine Project

New Mexico Environment
Department

Pecos Mine Reclamation

Reclamation Overview

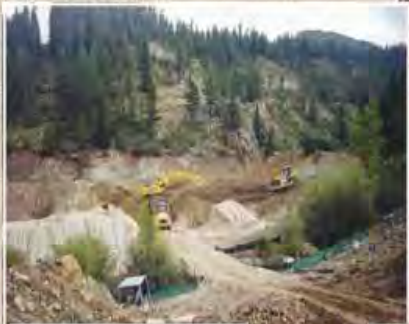
Willow Creek Waste Rock Excavation - 1999

Willow Creek, a local tributary to the Pecos River, borders the Pecos Mine's northern boundary. Waste rock generated from mining operations, was deposited into the creek and surrounding floodplain, completely diverting the creek from its original pre-mining pathway until it was flowing entirely on waste rock deposits along the floodplain's southern edge.

Approximately 900 linear feet of Willow Creek was completely reconstructed after removal of nearly 65,000 cubic yards of waste rock from the Willow Creek floodplain. Reconstruction design incorporated non-impacted, upstream reach morphology considerations. (Continued on next page)

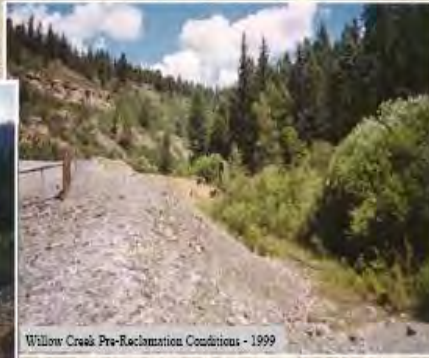
Willow Creek Pre-Reclamation Conditions - 1999

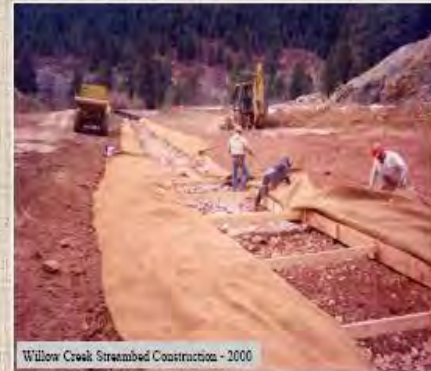
Willow Creek Streambed Construction - 2000

Willow Creek reconstruction work included: placement of a two-foot thick layer of heterogeneous cobbles, small boulders and gravel across the channel bottom and along the toe of each bank; placement of rock and soil backfill to recreate the bank slope adjacent to the stream channel; installation of continuous panels of woven and non-woven coir fabric banks backfilled with imported general fill; revegetation of the creek banks and riparian corridor with native, subirrigated grass, forbs and import and transplant woody species; and construction of a drop structure/fish barrier, step pools and grade control structures to ensure grade control within the steeply descending floodplain, channel stability and enhance aquatic habitat establishment.

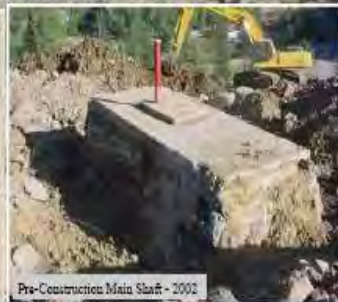
Pre-Construction Main Shaft - 2002

The Pecos Mine main shaft is located on the north end and at the top of the mine's waste rock pile and is 20.5-feet long, 6.8-foot wide and estimated to be over 700-feet deep. Reclamation construction operations in 2001 exposed workings from the side of the shaft, prompting further investigation as to it's condition, resulting in the need for an enhanced cover as an additional public safeguard and added protection against potential shaft cave-in.

The cover was constructed including construction of a reinforced concrete collar, two reinforced concrete anchor walls connected to the cover by a steel rebar network; a reinforced concrete cover placed over the concrete collar, and rock fall fabric netting extended from each anchor wall. In addition, a rock-filled gabion retaining wall was designed and constructed to provide the necessary stability for the anchor walls and the cover system, blending to the finished waste rock pile cap.

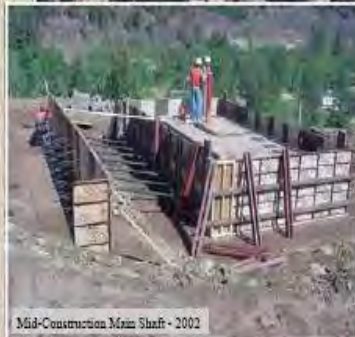
Mid-Construction Main Shaft - 2002

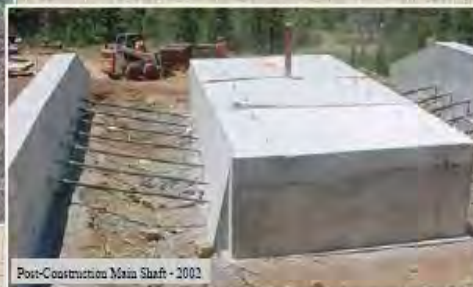
Post-Construction Main Shaft - 2002

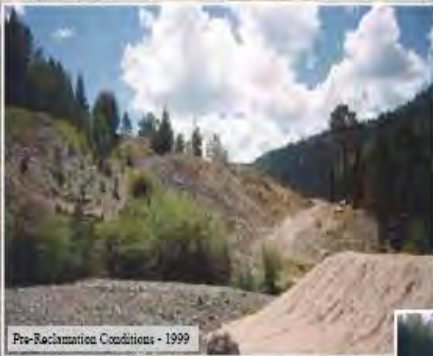
Pre-Reclamation Conditions - 1999

An estimated 125,000 cubic yards of waste rock, tailings, impacted soils, wetland sediments and mining debris were consolidated and regraded within the Pecos Mine's main waste rock pile area. Consolidation was designed to incorporate all waste materials into one, continuous pile in preparation for capping. Materials consolidation work was initiated in 1999 and was completed in 2002.

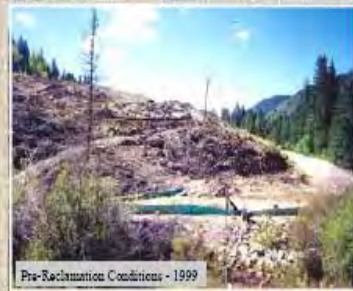
Pre-Reclamation Conditions - 1999

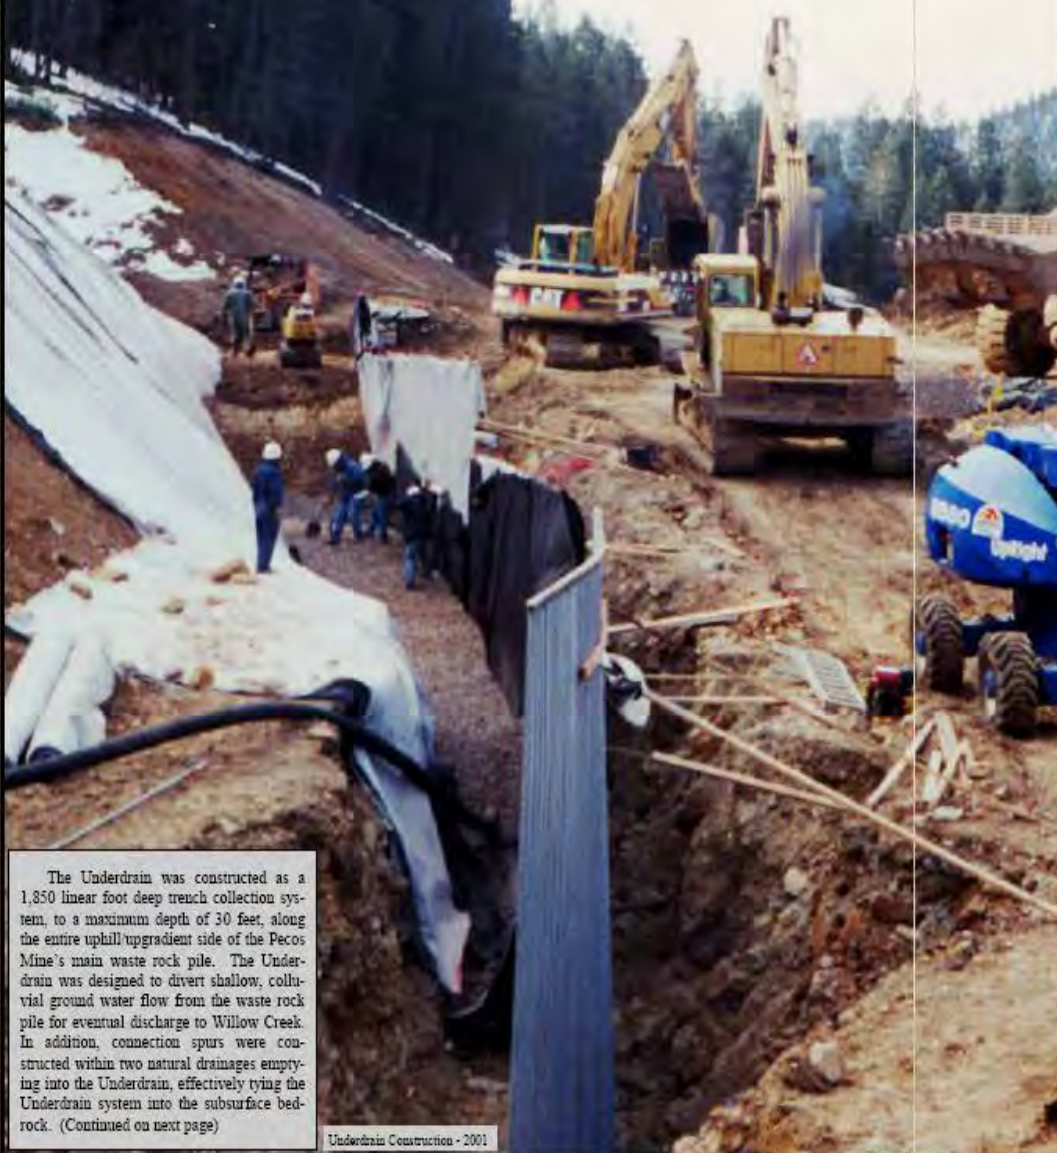
Underdrain Construction - 2001

The Underdrain was constructed as a 1,850 linear foot deep trench collection system, to a maximum depth of 30 feet, along the entire uphill upgradient side of the Pecos Mine's main waste rock pile. The Underdrain was designed to divert shallow, colluvial ground water flow from the waste rock pile for eventual discharge to Willow Creek. In addition, connection spurs were constructed within two natural drainages emptying into the Underdrain, effectively tying the Underdrain system into the subsurface bedrock. (Continued on next page)

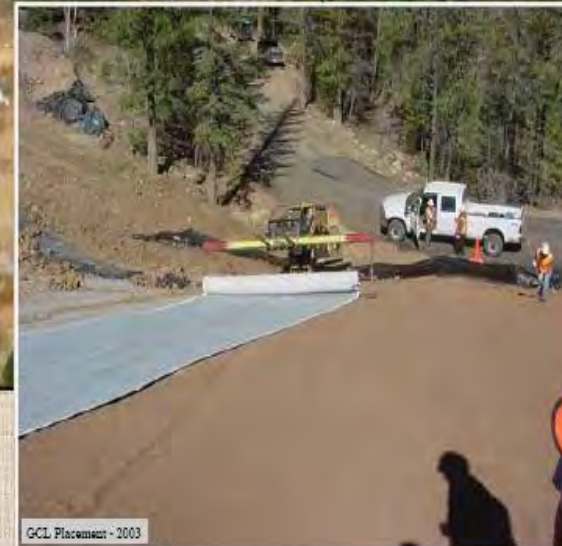
GCL Placement - 2003

A 13 acre cap system was constructed across the entire consolidated Pecos Mine main waste rock pile. The cap system was designed as a semi-impermeable hydrologic barrier, including a 6-inch prepared clay bedding layer, a geosynthetic clay liner and a 24-inch loosely compacted topsoil layer. Approximately 53,000 cubic yards of soil materials were imported from near and off site borrow areas for construction of the cap subgrade and topsoil layers.

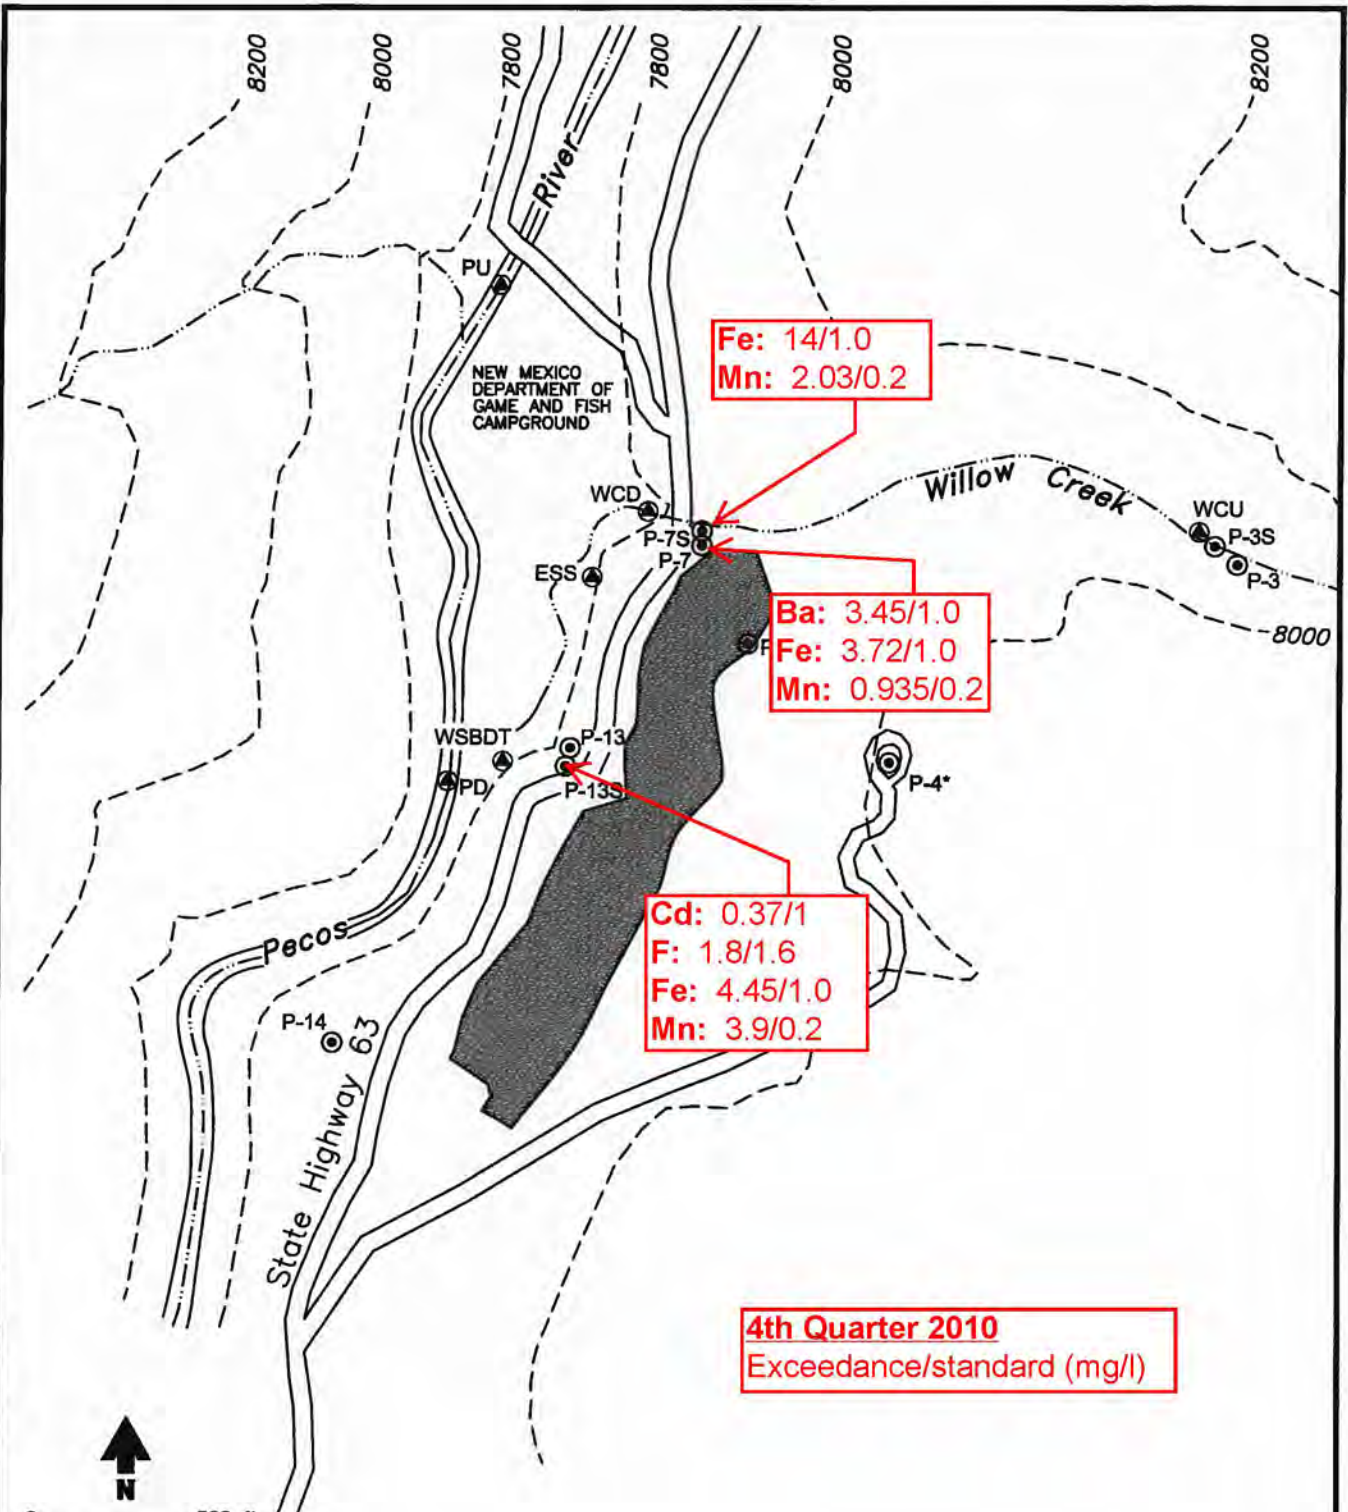
Figure 1

Fe: 14/1.0
Mn: 2.03/0.2

Ba: 3.45/1.0
Fe: 3.72/1.0
Mn: 0.935/0.2

Cd: 0.37/1
F: 1.8/1.6
Fe: 4.45/1.0
Mn: 3.9/0.2

4th Quarter 2000
Exceedance/standard (mg/l)
