Sunday, August 23, 2015

Causes of Gold King mine spill emerging

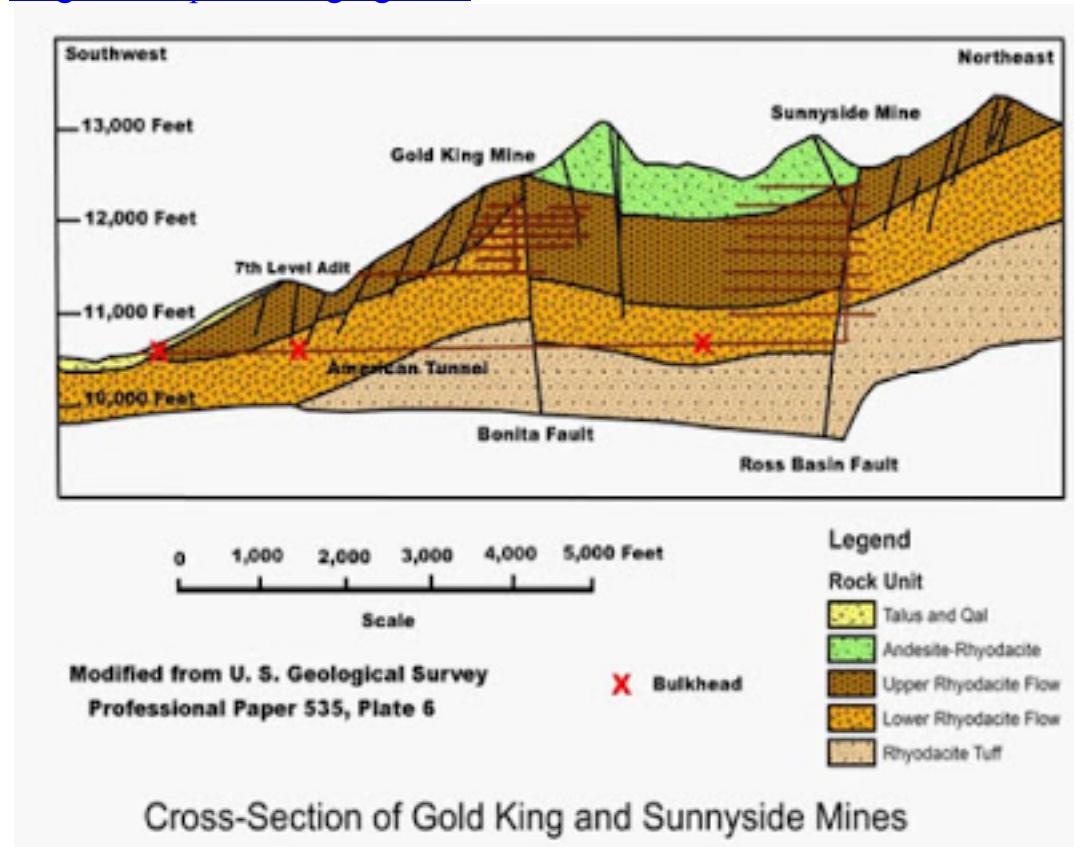
Tucson-based consulting geologist David Briggs published an article in the *Arizona Daily Independent* describing the history of mines on the mountain including the closure of the Sunnyside mine in 1991. David reports that 12 bulkheads or engineered dams were built in underground tunnels, to control drainage of acid mine waters. David's interpretation is that groundwater flow through natural fractures and faults would discharge through these tunnels. But with them dammed and drainage halted, drainage in other mines, including the Red & Bonita and the Gold King 7th Level Adit, increased. [Right, geologic cross section of Gold King and Sunnyside mines, by David Briggs, modified from USGS Professional Paper 535]

David concludes "this is comparable to a bathroom sink that has a drain and overflow outlet. When the drain (i.e., American Tunnel) is open the water flows out the bottom of the sink. However, if you close the drain (i.e. wtih a bulkhead) the water will rise in the sink until it gets to the overflow outlet (i.e. Red and Bonita mine and Gold King 7th Level Adit)."

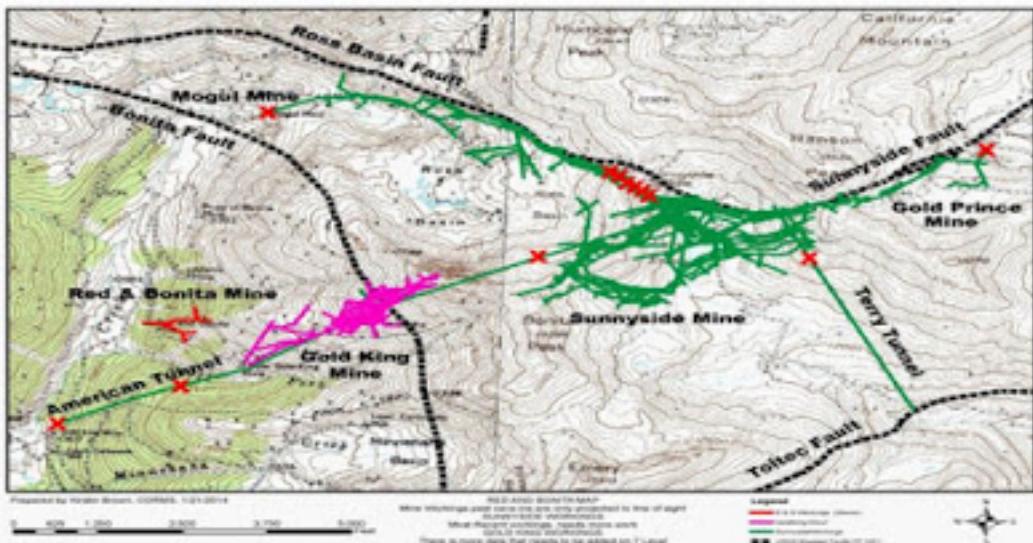
Map Showing the Surface Projection of Underground Mine Workings, Major Fault Zones and the Locations of Bulkheads (Red X's).

[Bottom right, map of mine workings including Red & Bonita and Gold Mine King, with named faults. Credit, EPA with additions by David Briggs]
