Partizansk Coal Ash Dam Break and Spill - Observations

Compiled September 28, 2004

Paul Robinson

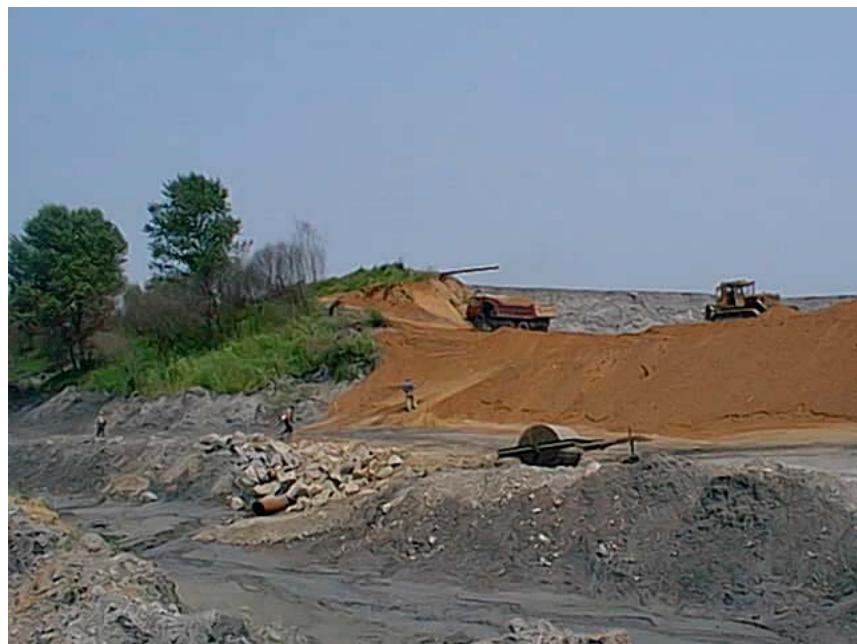
- 1) The dam containing coal ash produced at the Partizansk Coal-fired Electric Power Station broke on May 22, 2004, releasing approximately 160,000 cubic meters of ash into a drainage canal that flowed into a tributary to the Partizanskaya River which empties into Nahodka Bay in Primorski Krai, Russia east of Vladivostok. The break left a hole roughly 50 meter wide in the dam.

1 of 7 - View of the breach area being filled in also showing the height of the dam, the discharge point for emergency drainage pipe at the base of the breach area, the slope of dam and the height of mature trees growing in dam

- 8) An emergency drainage system of slotted pipe had been installed at the breach site at the time of a site visit on July 22, 2004 when material was observed being placed in the breach area. The pipe discharges liquid collected from the breach zone to the drainage canal where spilled fly ash had flowed. The 60 cm was flowing at 0.1 liter/second according to a contract geologist working on site.

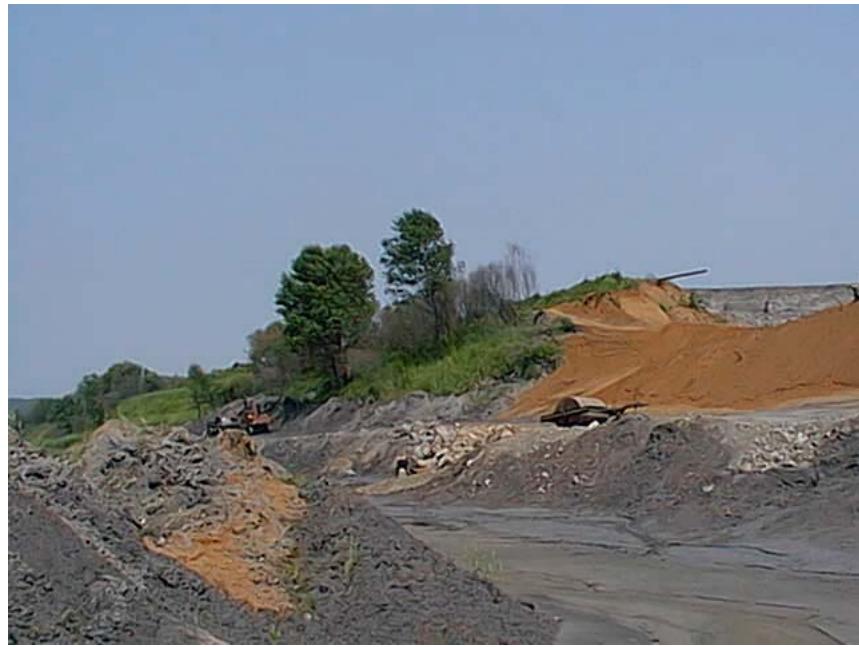
- 6) The drainage canal ditch parallels the west side of the ring dike and flowed to a creek that is tributary to the Partizanskaya River. The drainage canal was completely filled with ash during the spill for the roughly one kilometer between the breach site and the tributary creek. The ash released by the spill covered the bed and floodplain of the tributary creek and flowed into the Partizanskaya River.

- 7) The drainage ditch was approximately 5 m x 5m in cross section. Only about 25,000 cubic meters (5 m x 5m x 1000m) of the spilled fly ash collected in the drainage canal and roughly 135,000 cubic meters of spilled ash were flowed into the Partizanskaya River watershed.

2 of 7 - View of drainage canal filled with fly ash and construction equipment removing portions of toe of dam

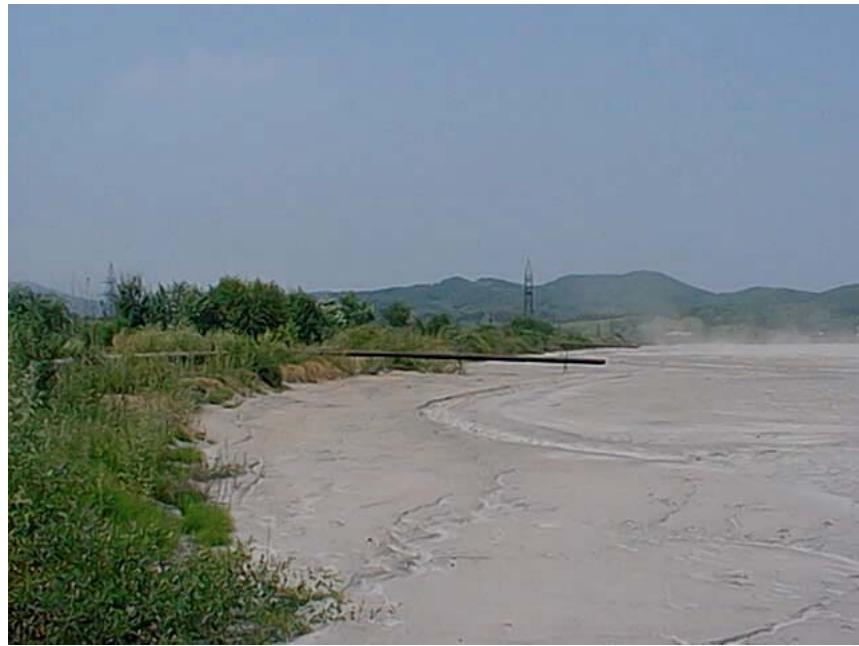
- 3) The dam has been built solely from coal ash and is over full, as ash reaches within 50 cm of the crest of the dam leaving almost no room for accumulation of water from precipitation or future ash generated at the plant. The ring dike encloses an area of roughly 1 kilometer x 1 kilometer x 20 meters and a volume of roughly 20,000,000 cubic meters.

3 of 7 - View of crest of dam showing how full completely full it is with coal ash

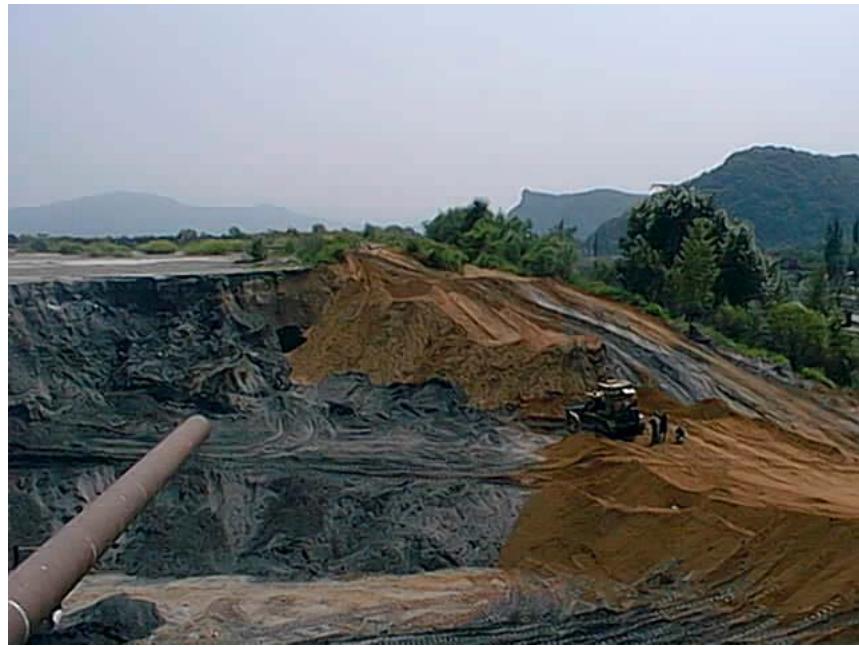
4 of 7 - View of breach zone from within the ring dike dam

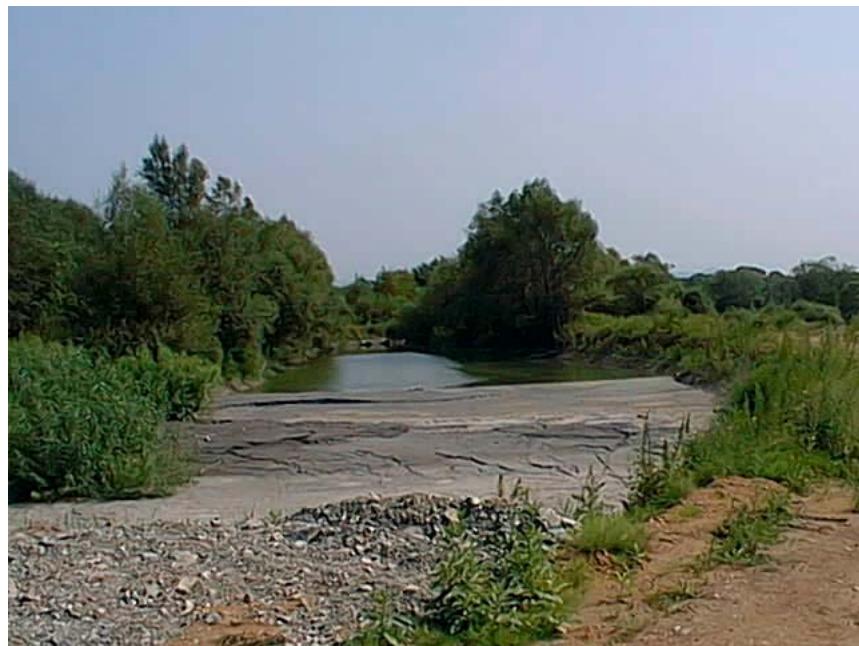
5 of 7 - View of ash where drainage canal discharges to tributary to Partizanskaya River

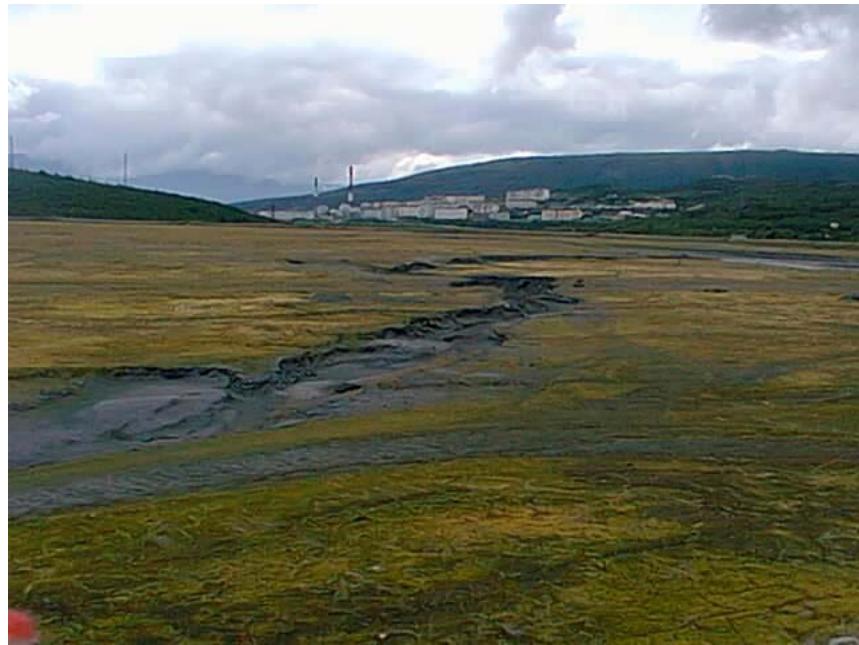
12) The problems at the Partizansk fly ash dam that contributed to its failure - overfull impoundment, lack of groundwater and stability monitoring, lack of future site preparation, and flood plain location - appear to exist at the Magadan Electric Power Plant and are likely to be occurring at many of the hundreds of coal-fired power plants around Russia and the former Soviet Union due to the widespread lack of monitoring and maintenance waste sites since 1990s.

6 of 7- View of full coal ash disposal dam - a ring dike - at primary power plant at Magadan City located in flood plain of Magadan River

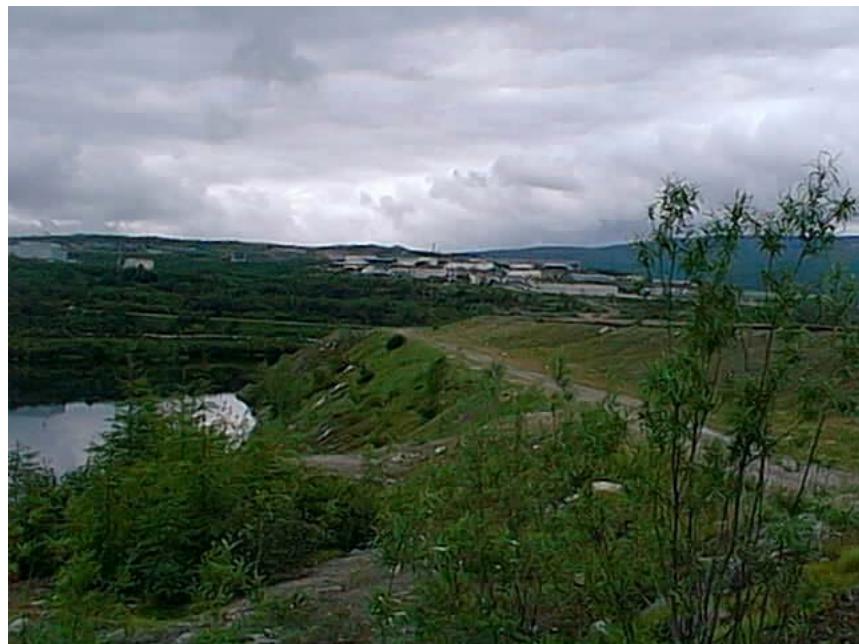
7 of 7 - View of downstream face of Magadan Power Plant coal ash dam showing the toe of the dam located in the floodplain of the Magadan River
