Statement by George Anastas on Behalf of Southwest Research and Information Center Relating to

NOTICE OF INTENT TO APPROVE A CLASS 3 MODIFICATION TO CLARIFY TRU MIXED WASTE DISPOSAL VOLUME REPORTING AT THE WASTE ISOLATION PILOT PLANT (WIPP) CARLSBAD, NEW MEXICO Facility Name: Waste Isolation Pilot Plant

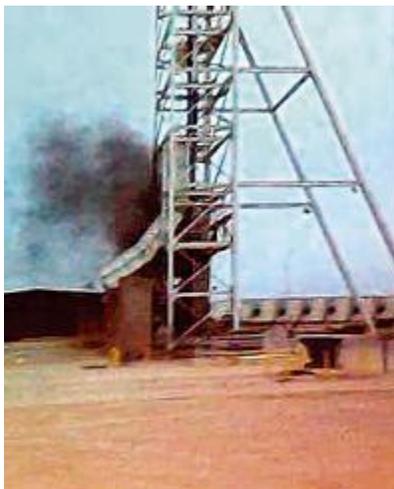
“(T) the Facility Shift Manager (FSM) directed the CMRO (ed. Central Monitoring Room Operator) to switch the ventilation system from normal to filtration mode believing this would reduce both the fire and smoke in the underground. However, this resulted in the flow of smoke into areas of the underground, which the workers expected to have “good” air. Eighty-six workers were in the underground and a total of 13 workers were treated; six transported to a local hospital and seven treated on-site.”

Smoke from the smoke truck fire billowing out the salt shaft! (Source: WordPress.com)
