# Renewed Gold Mining in Planned in Baja California Sur: Location, Current Plans, Environmental Issues at Mines and Initial Observations about the Current Plans

June 2009

Paul Robinson  
Research Director  
Southwest Research and  
Information Center  
PO Box 4524  
Albuquerque, NM 87196 USA  
1-505-262-1862  
sricpaul@earthlink.net  
www.sric.org

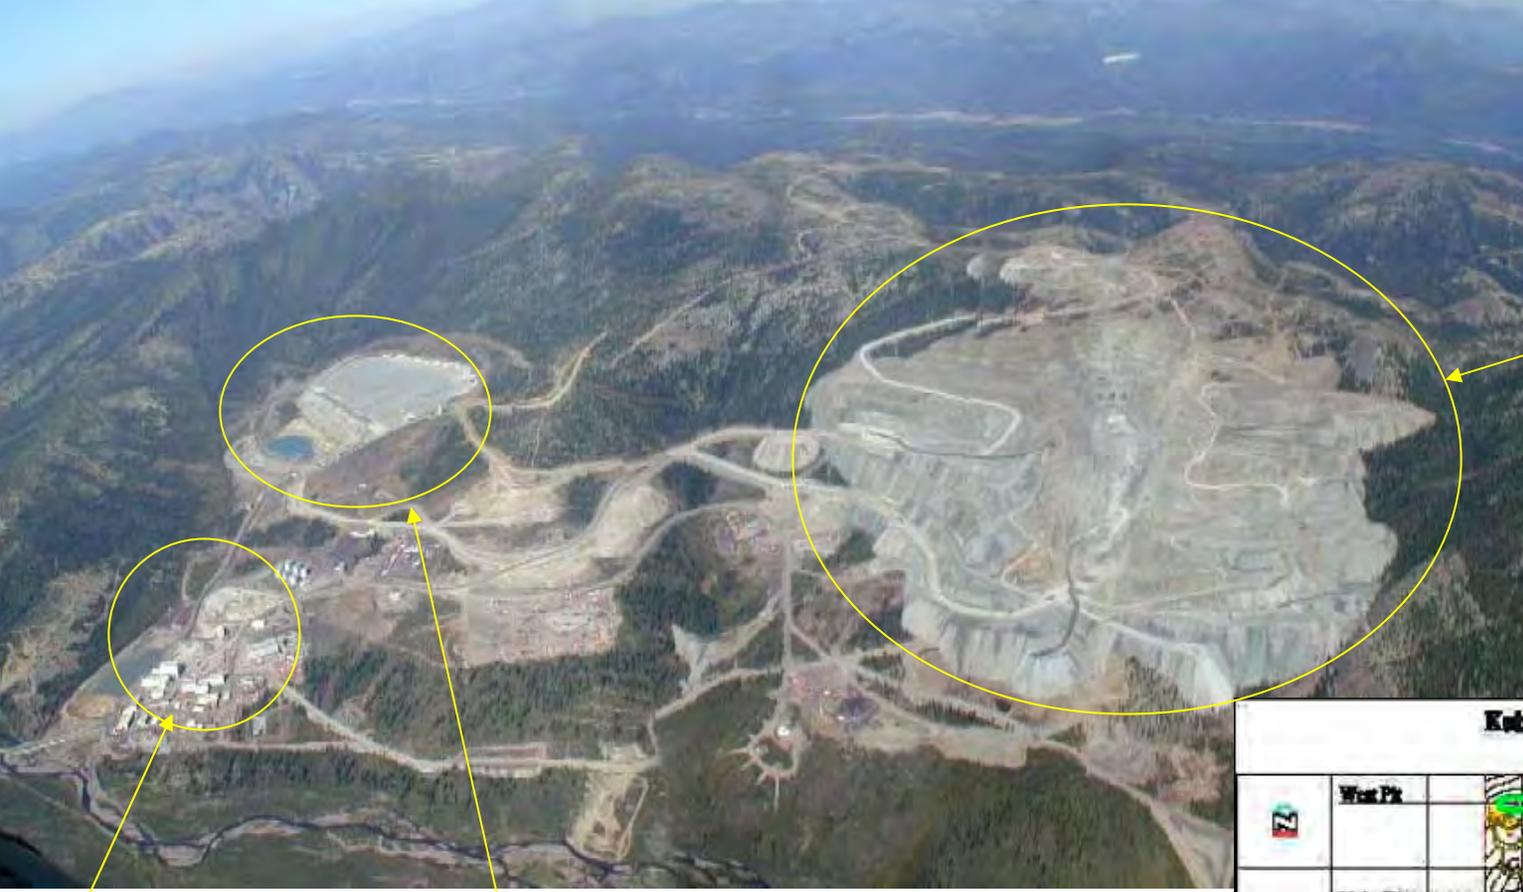
Kubaka Gold Mine and Mill Complex, 2003 - Kinross Gold  
Magadan Region, Russia

Open Pit Mine and Waste Rock Piles

Gold Mill

Tailings Dam and Tailings Pile behind Dam

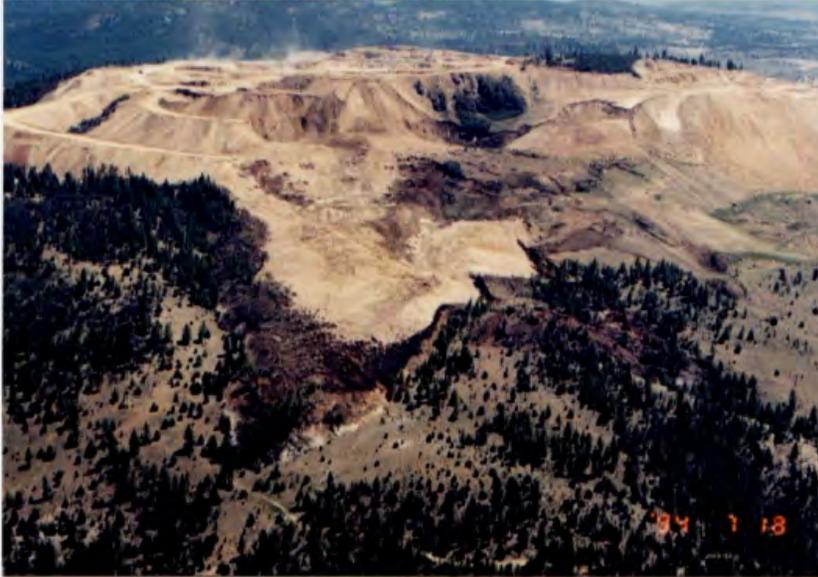
Photo 1. Aerial view of initial dump slide area – 1994.

# Waste Rock Dump Slope Failure

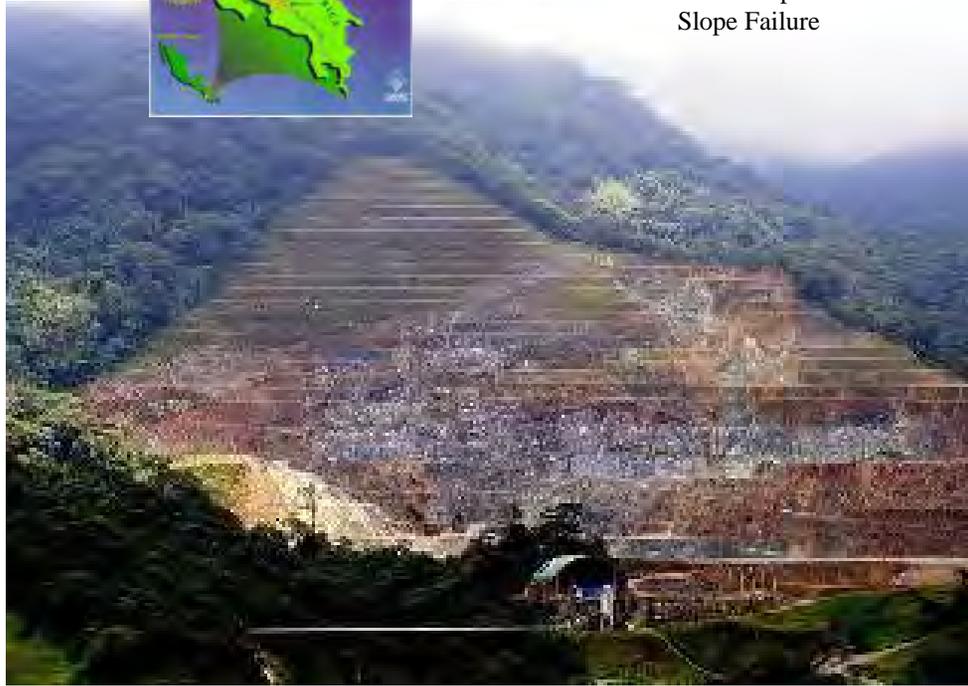
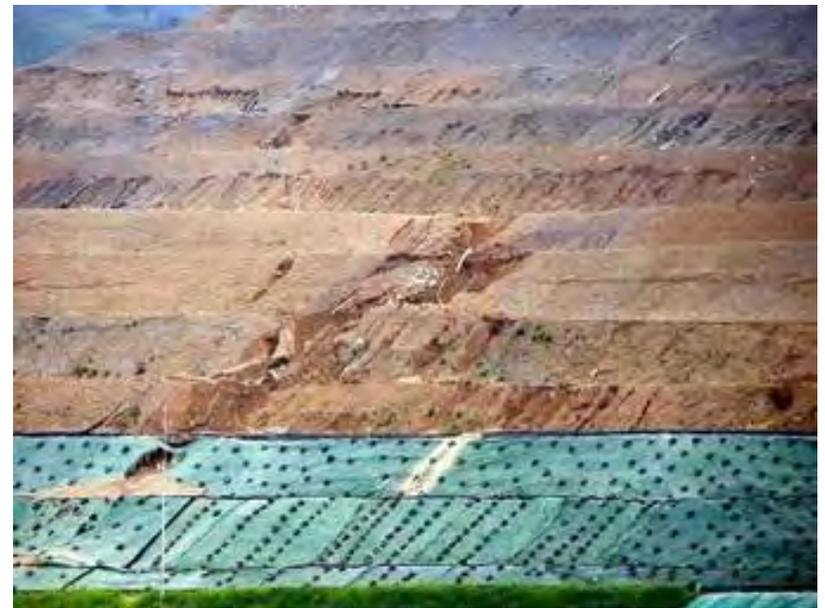
2007 Heap Leach Pad  
Slope Failure

# Heap Leach Tailings Slope and Liner Failures: Bellavista Gold Mine, Costa Rica

Bellavista is an open pit gold mine, and uses cyanide heap-leaching – in which huge piles of crushed ore are soaked with a cyanide solution – to extract gold.

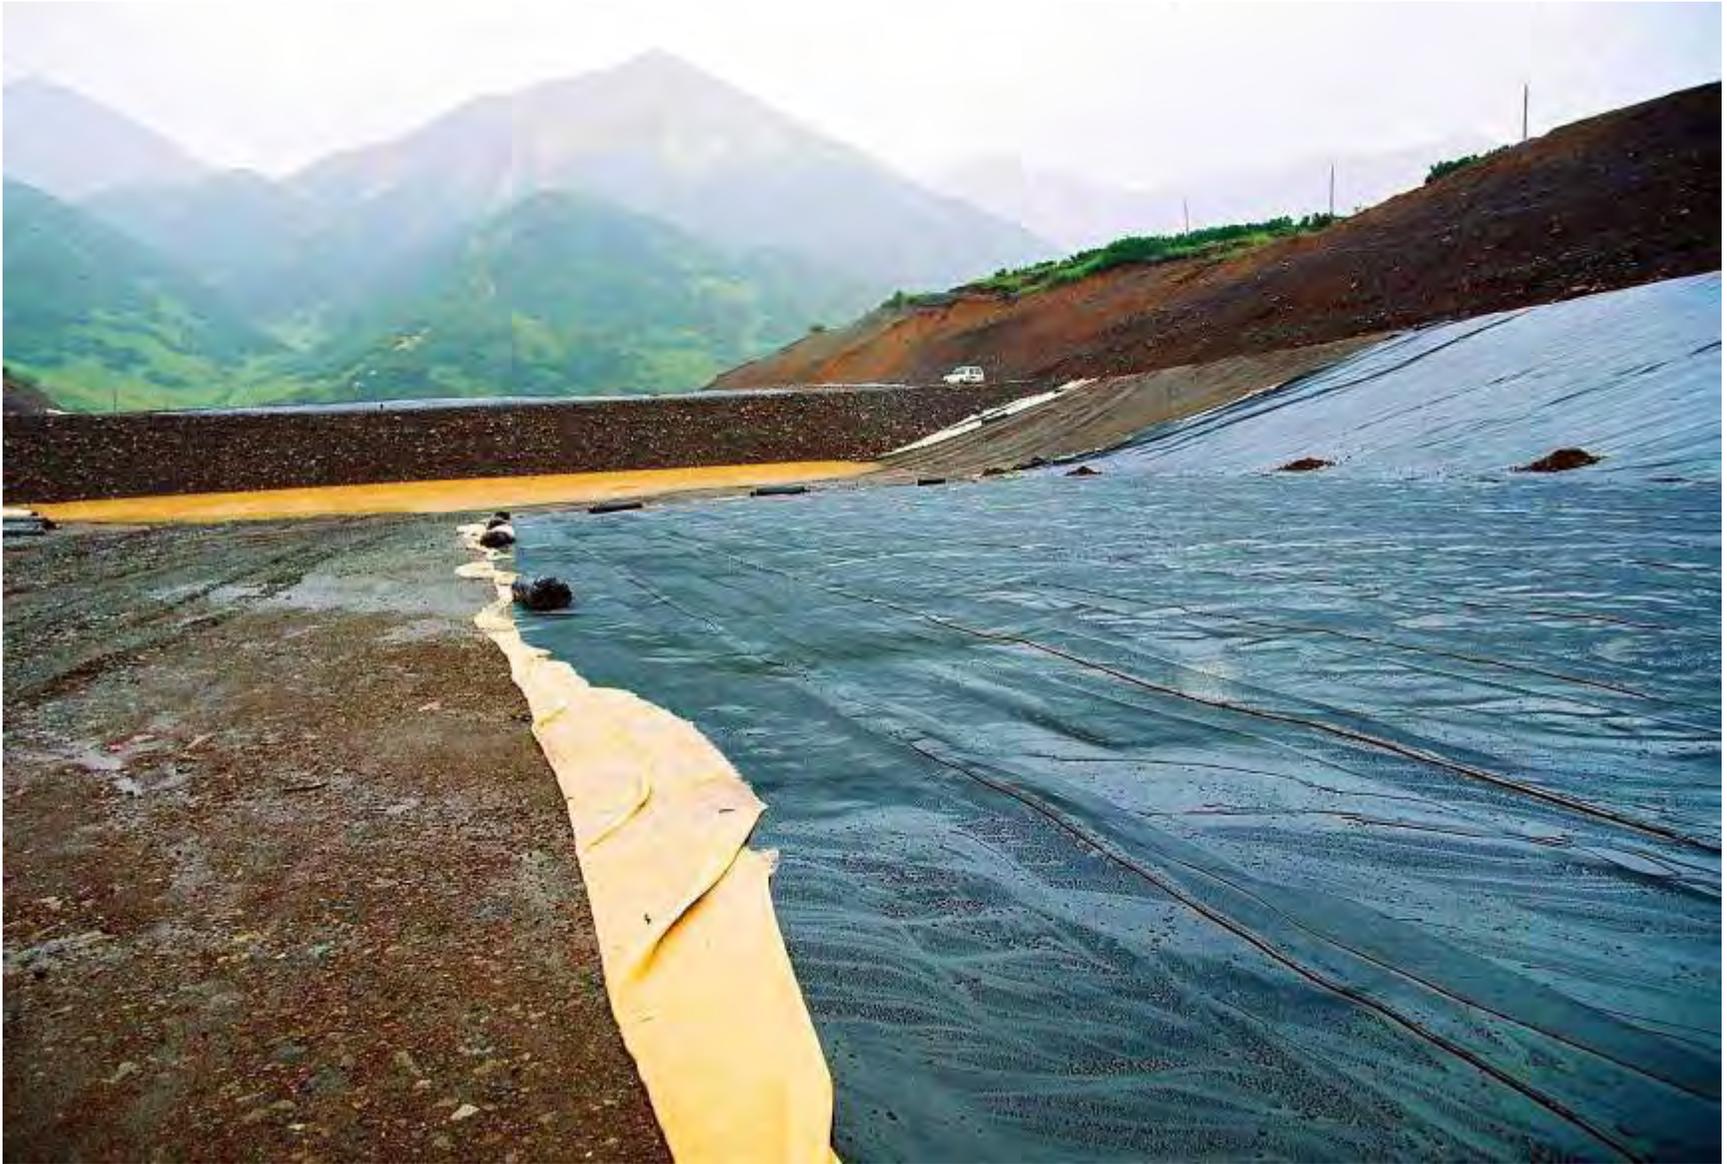
Aginskii Tailings Dam, Kamchatka, Russia, During Liner Installation showing Substrate - “Pillotka” under Liner, Geo-Membrane over Sub-Strate, and Liner Film with Welded Seams - 2005 [Substrate more typically specified as sand rather than pebbles and cobbles]

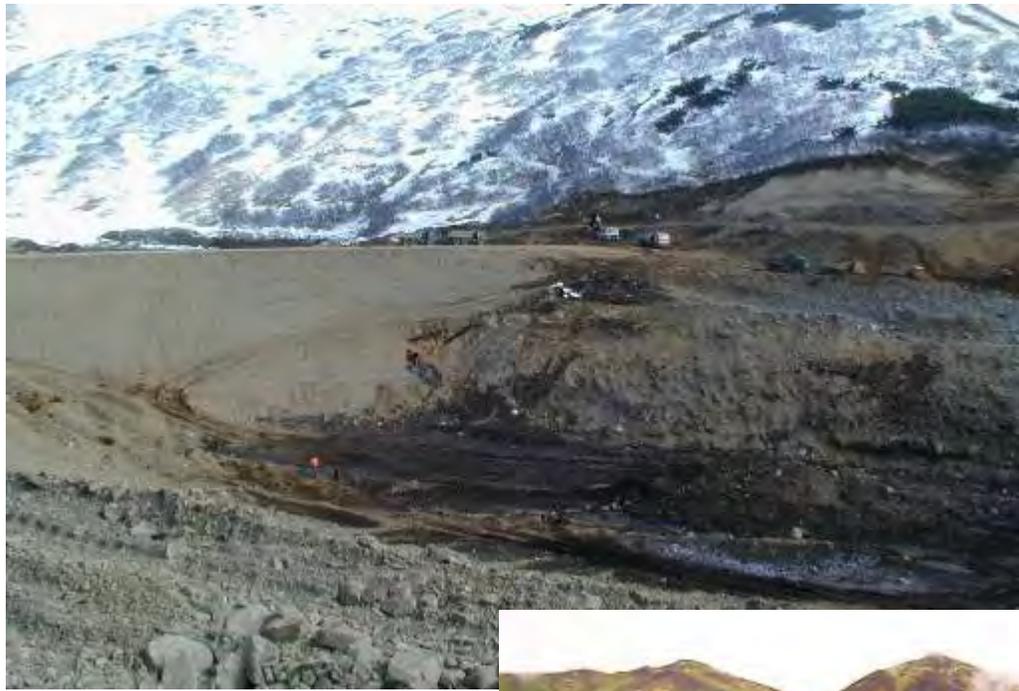
Aginskii Gold Mill Tailings Dam  
During Slope Construction Before  
Liner Installation - 2004 - [Note wet  
zone at base of construction area]

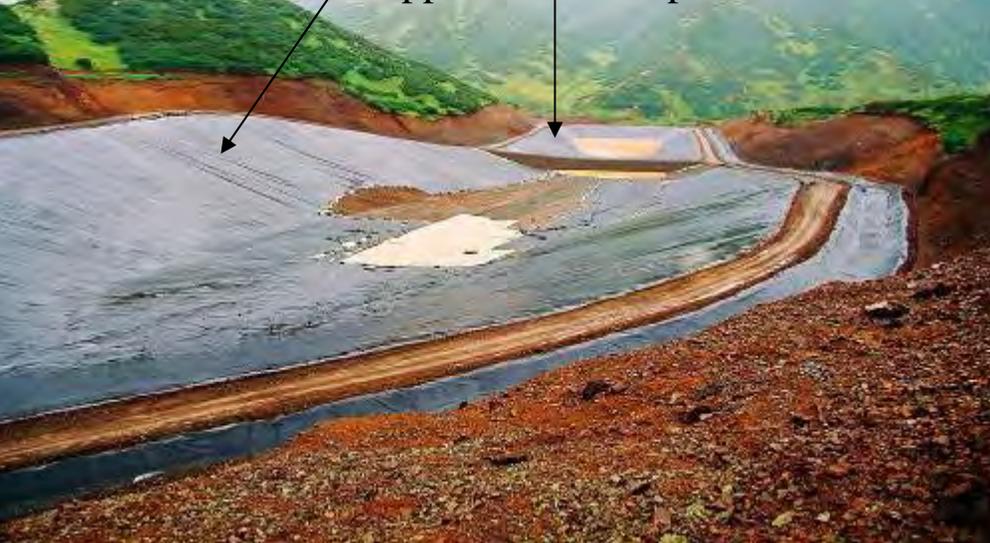
Aginskoe Liner 2005 looking downstream - black liner surface evident on upper and lower ponds

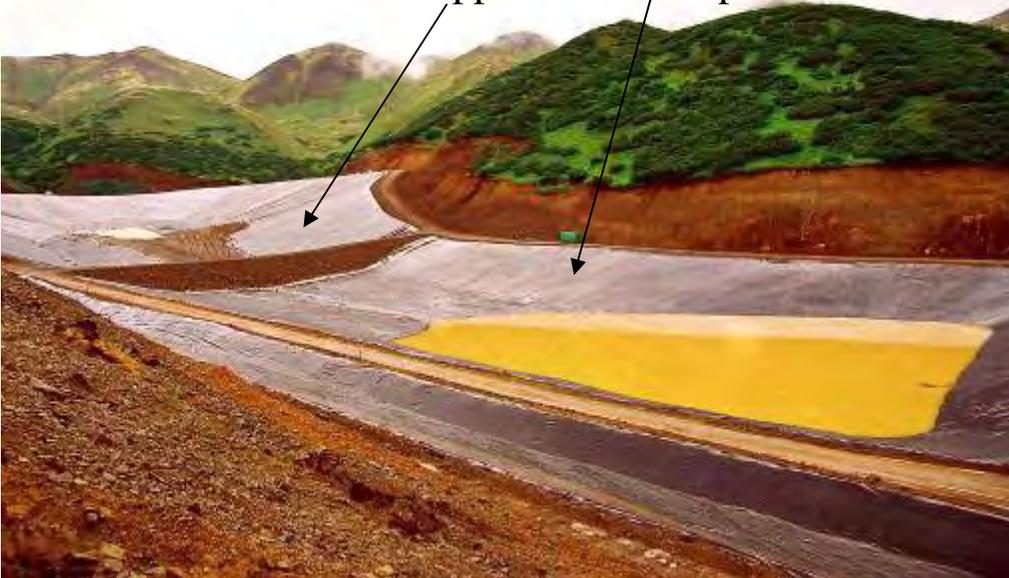
Aginskoe Liner 2007 - Liner on upper pond shows extensive tearing of geomembrane - white material - and liner surface - black material

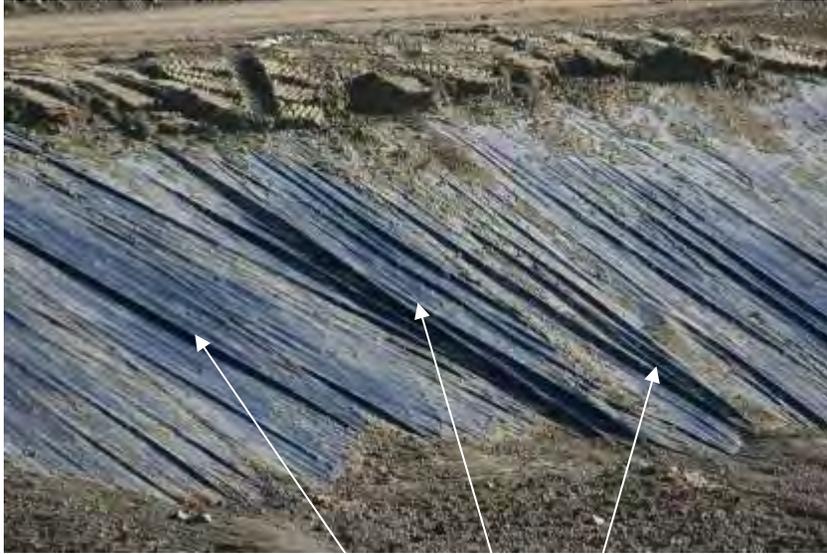
Aginskoe 2007 Liner - Wrinkles in, and overlaps of, liner materials illustrate faulty liner system installation and maintenance..

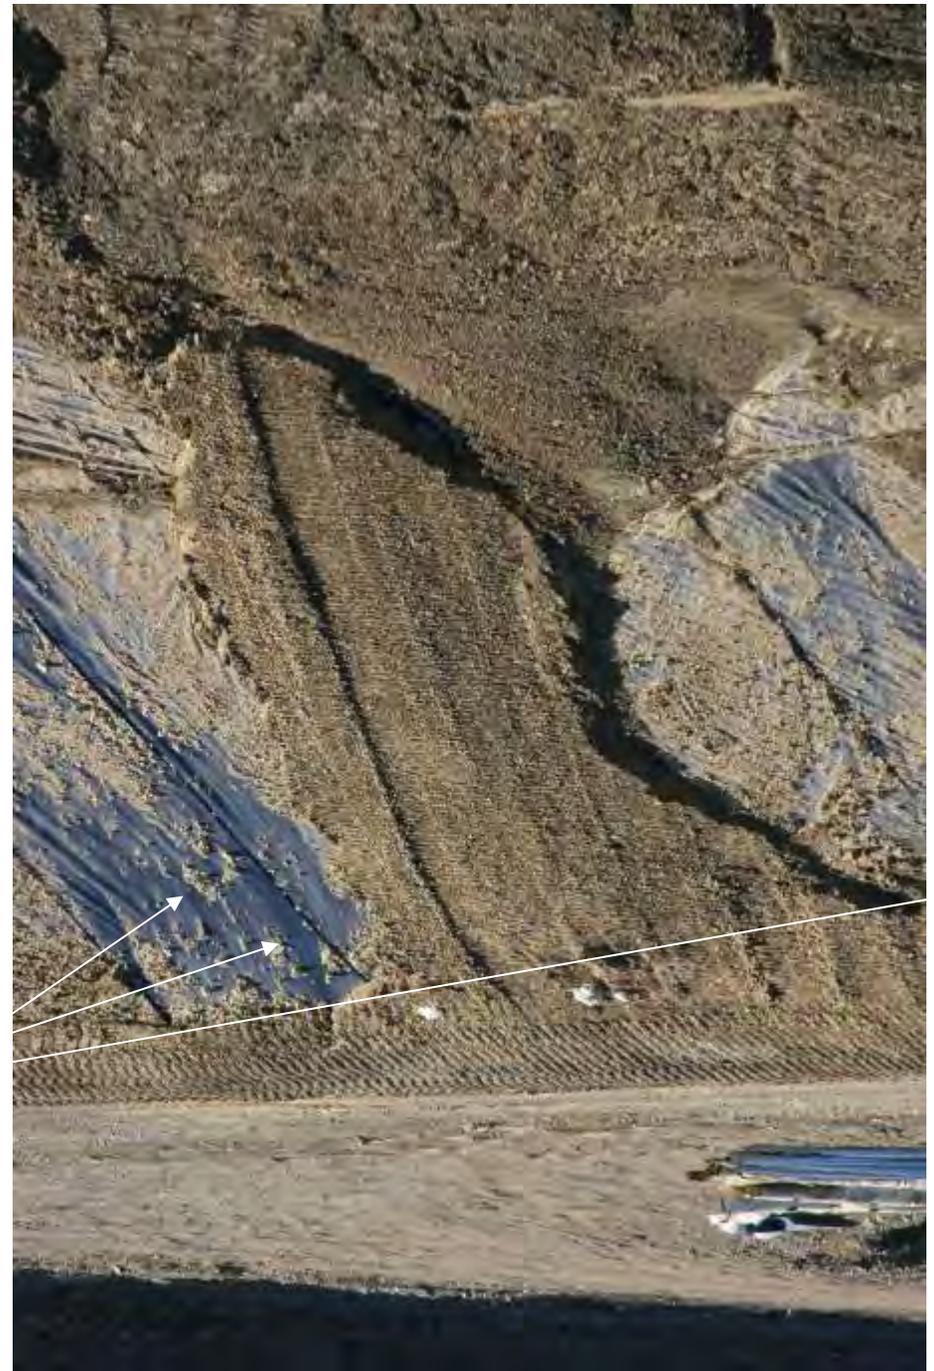
Aginskoe 2007 Liner - Extensive pattern of holes in liner material demonstrates that potential to prevent leaks has been destroyed for this portion of the liner

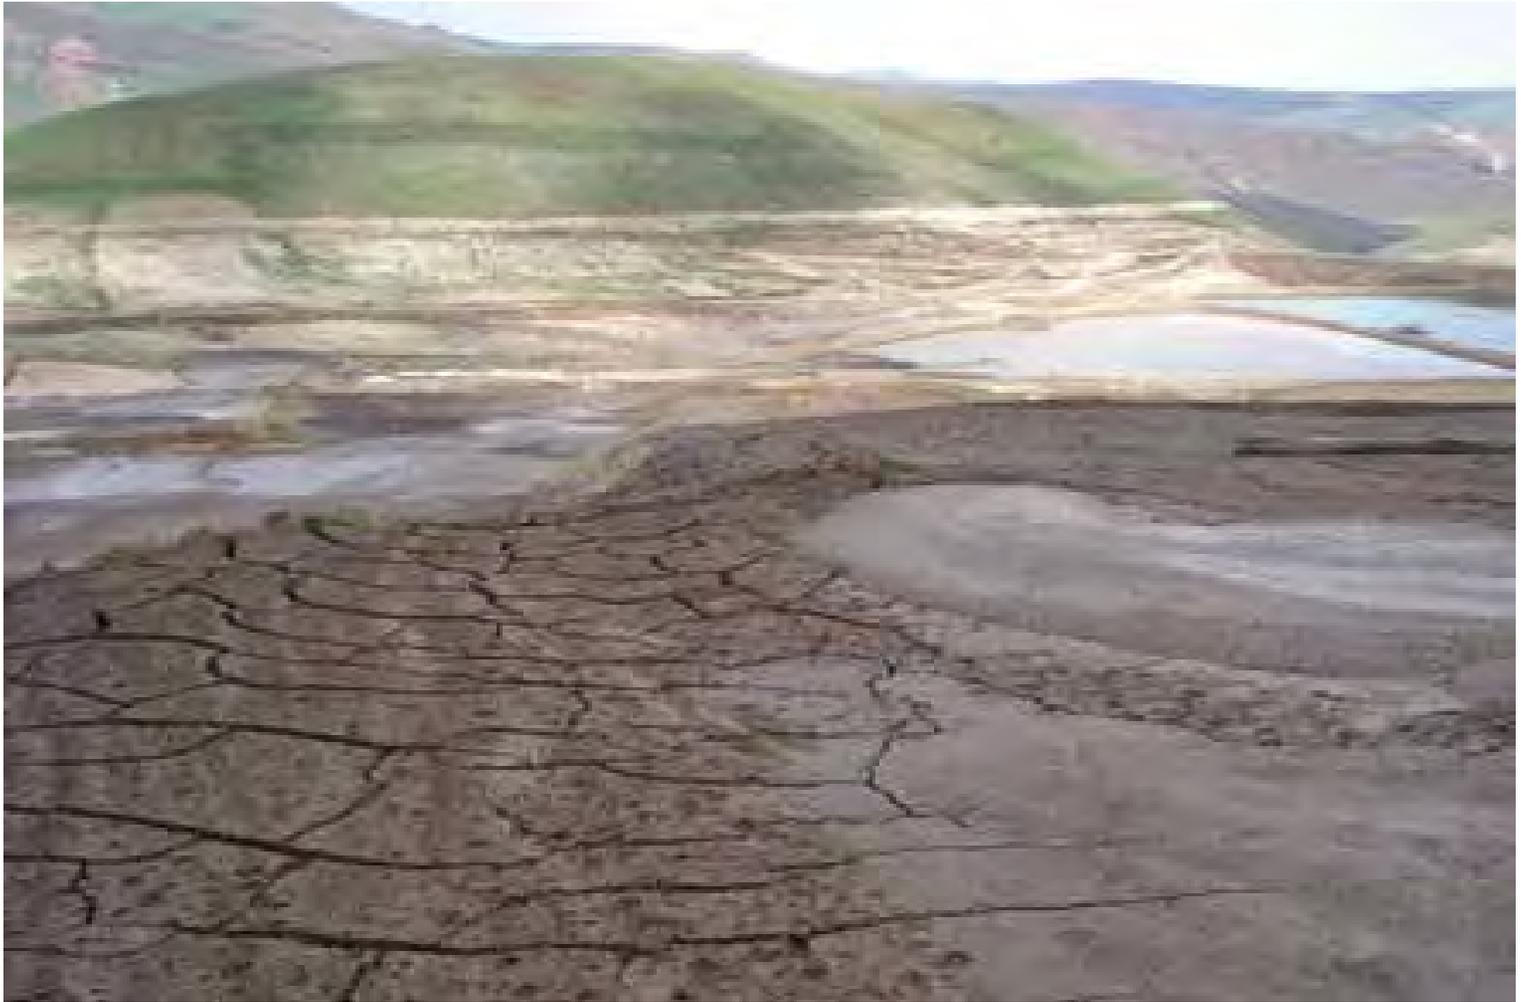
A paste deposit, as shown here, is one alternative among many in a range of possible thickened tailings formulations. The right choice for any specific tailings application depends on a variety of factors.

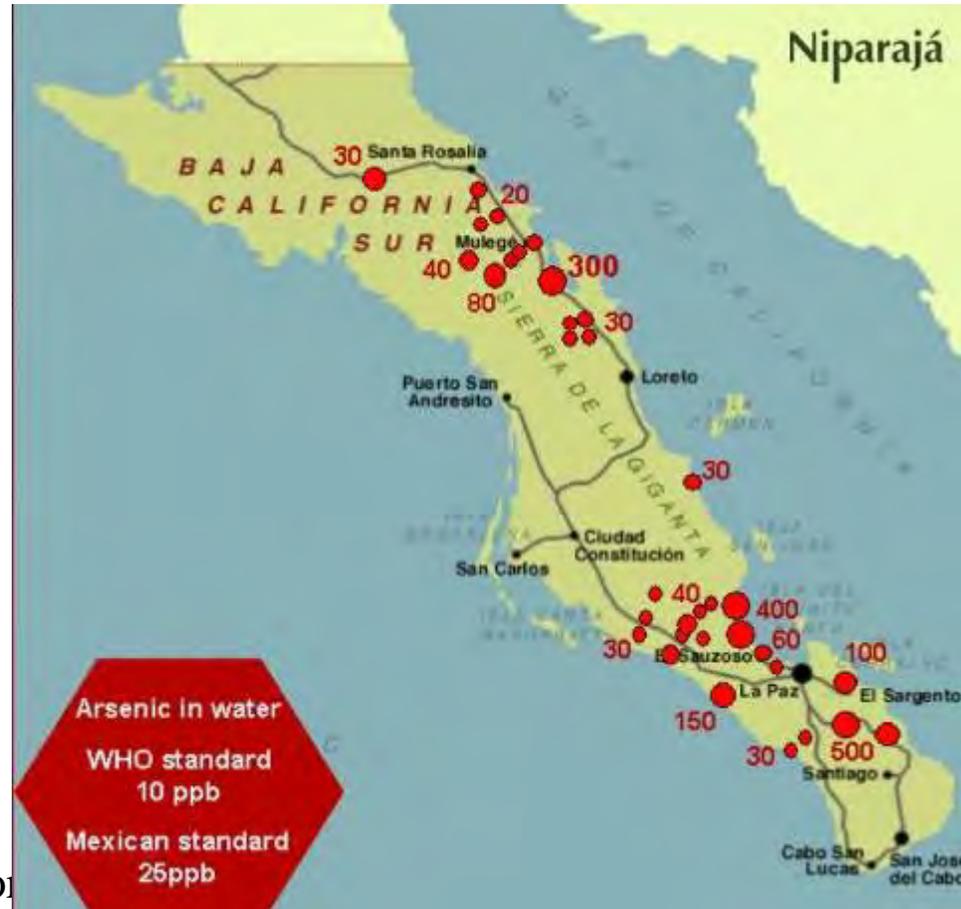
Arsenolite ( $\text{As}_2\text{O}_3$ ) was historically produced as a byproduct of gold and silver extraction in Southernmost Baja California Peninsula. There are in the San Antonio-El Triunfo area more than 800,000 tons of mine waste material with an average content of 4% arsenic oxide.

The chemical reaction to produce arsenic trioxide (arsenolite) was the oxidation of arsenopyrite ( $\text{AsFeS}$ ) with gold (ore) to produce iron oxide ( $\text{Fe}_2\text{O}_3$ ) with gold and releasing  $\text{SO}_2$  and  $\text{As}_2\text{O}_3$  fumes. During the process the arsenic fumes sublimated onto the inner walls of old, mineral processing plants.

When the chambers filled up, they were periodically emptied out on big piles of oxidized tailings. But once the plants were abandoned, the chambers remain half filled with approximately 600 tons of pure arsenolite.

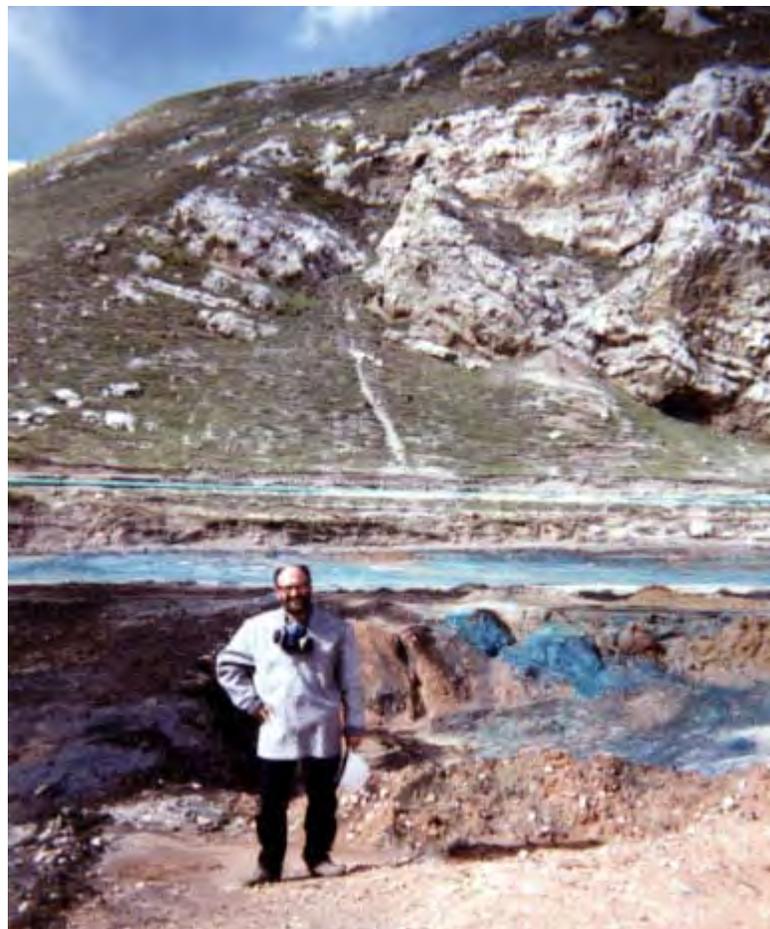
Arsenic trioxide waste at La Oroyo, Peru
